**CERCLA
EXPANDED SITE INSPECTION**

**LEFTON IRON & METAL
East St. Louis, Illinois
ILB984809244
L0570250003**

**PREPARED BY:
ILLINOIS ENVIRONMENTAL PROTECTION AGENCY
BUREAU OF LAND
DIVISION OF REMEDIATION MANAGEMENT
OFFICE OF SITE EVALUATION**

September 6, 2005

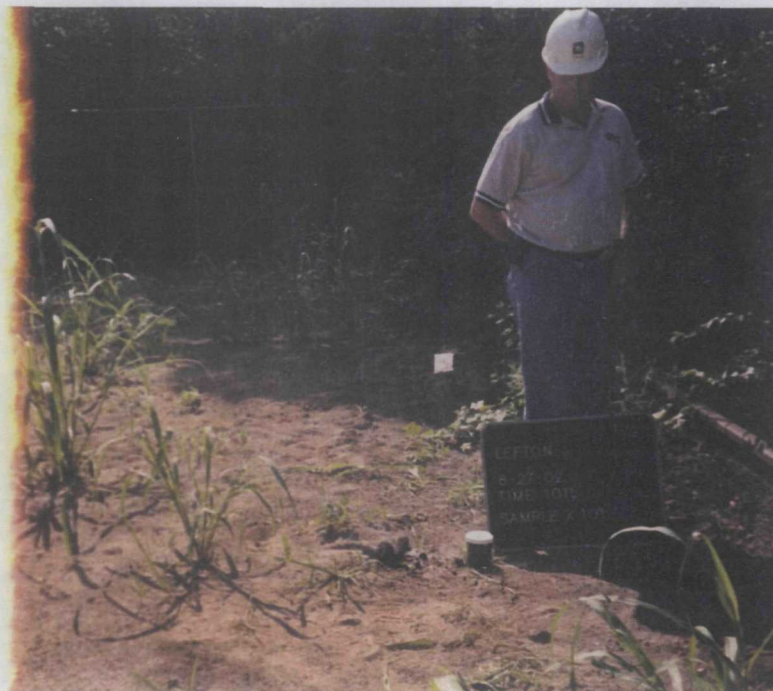
COMMENTS: Photo of soil sample X101. X101 was collected near the main entrance to the Converse Avenue facility.

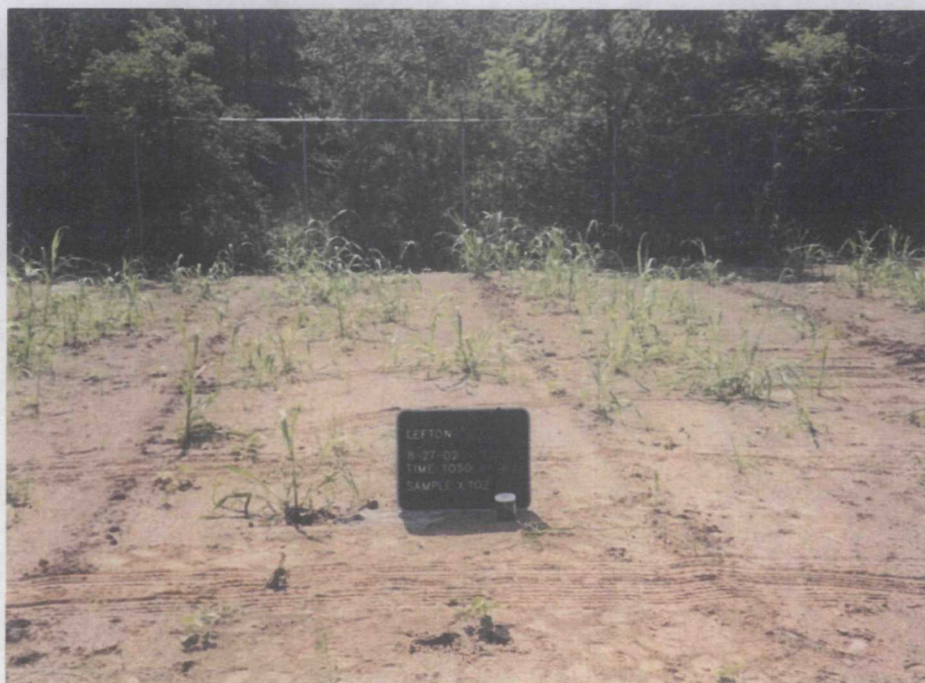
COMMENTS: Photo of soil sample X102. X102 was collected near the main entrance to the Converse Avenue facility.

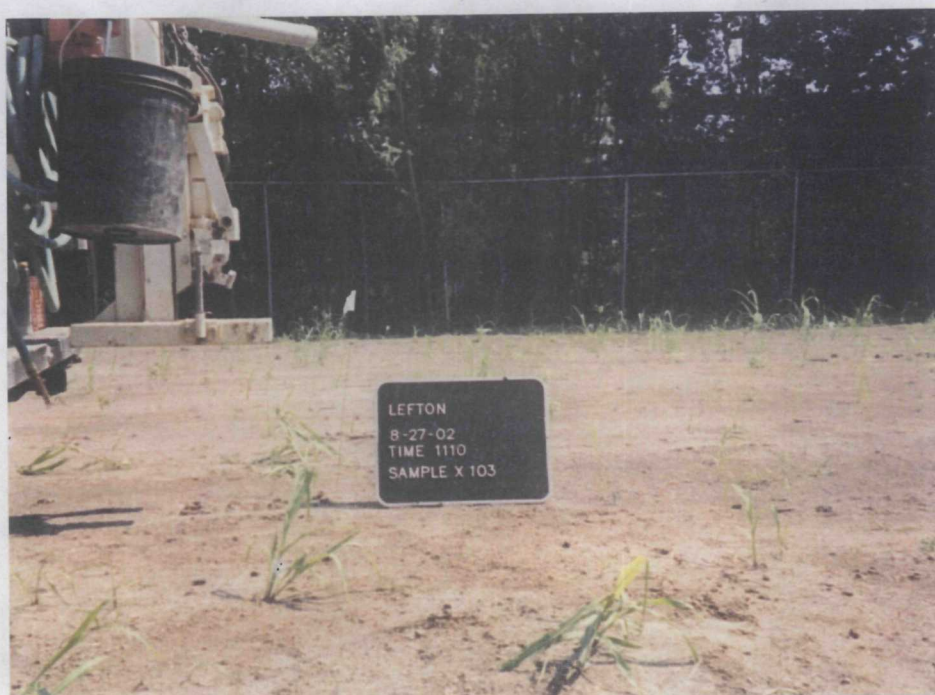
COMMENTS: Photograph of soil sample X103. X103 was collected in an area that was used at the Converse Avenue facility to accumulate scrap materials.

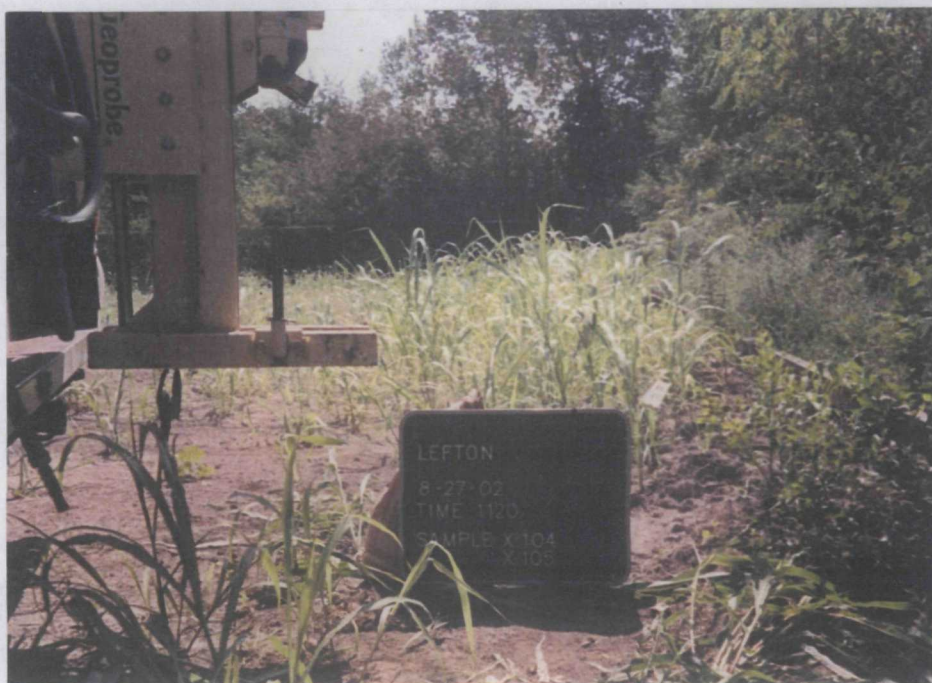
COMMENTS: Photograph of duplicate soil samples X104 & X105. X104 & X105 were collected in them main scrap and area of the Converse Avenue facility.

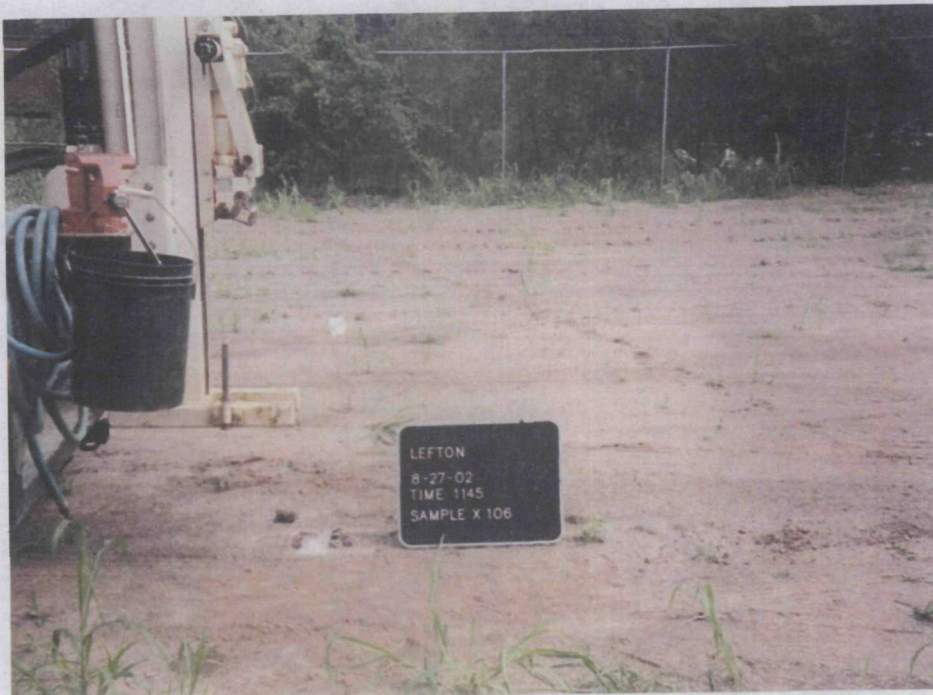
COMMENTS: Photo of soil sample X106. X106 was collected from the main scrap yard area of the Converse Avenue facility.

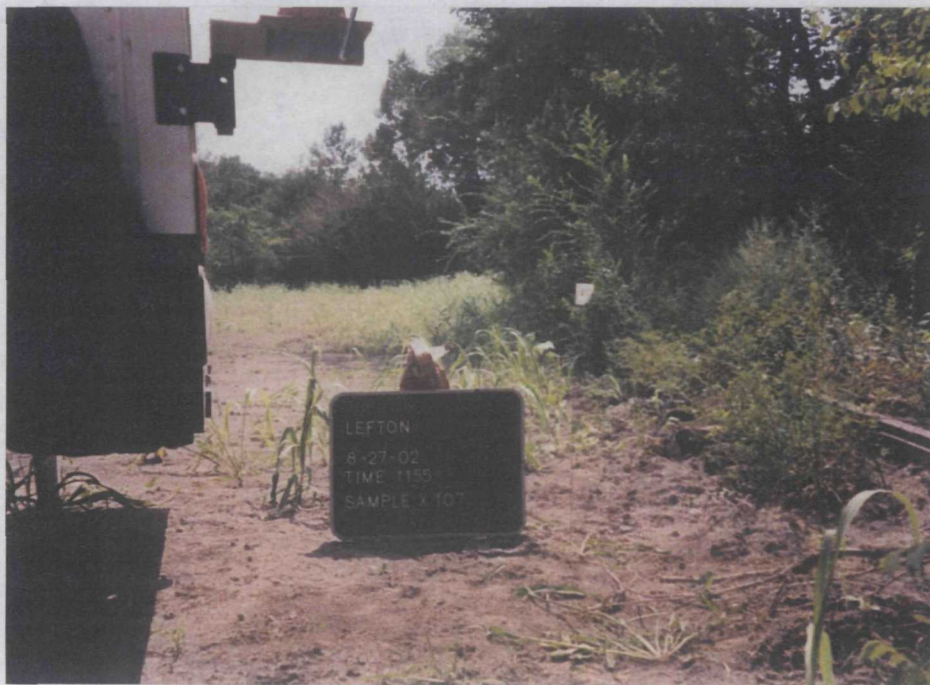
COMMENTS: Photo of soil sample X107. X107 was collected from the main scrap yard area of the Converse Avenue facility.

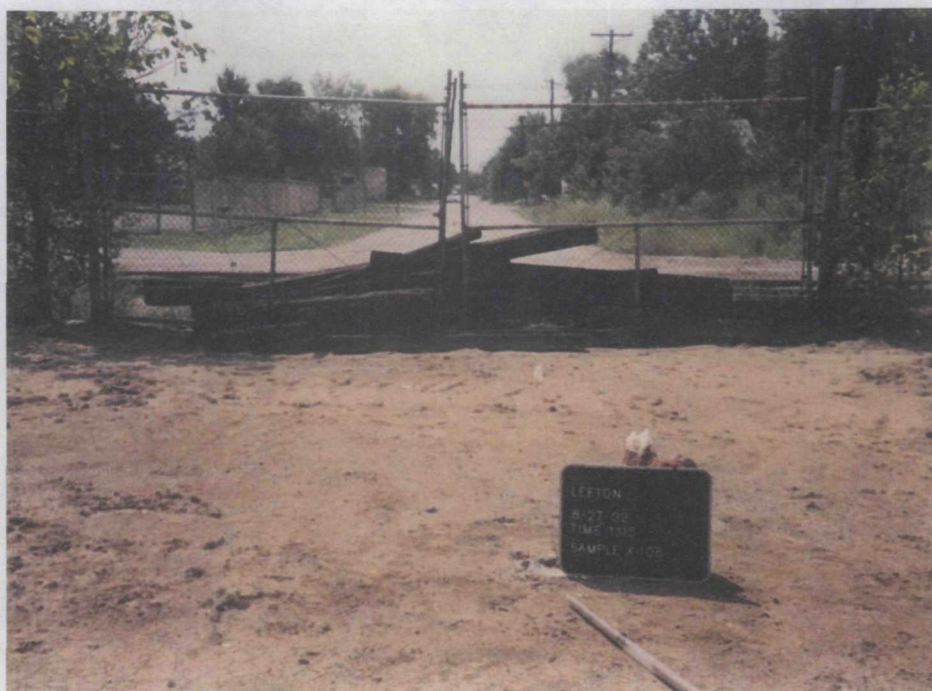
COMMENTS: Photo of soil sample X108. X108 was collected near the southwestern edge of the Converse Avenue facility.

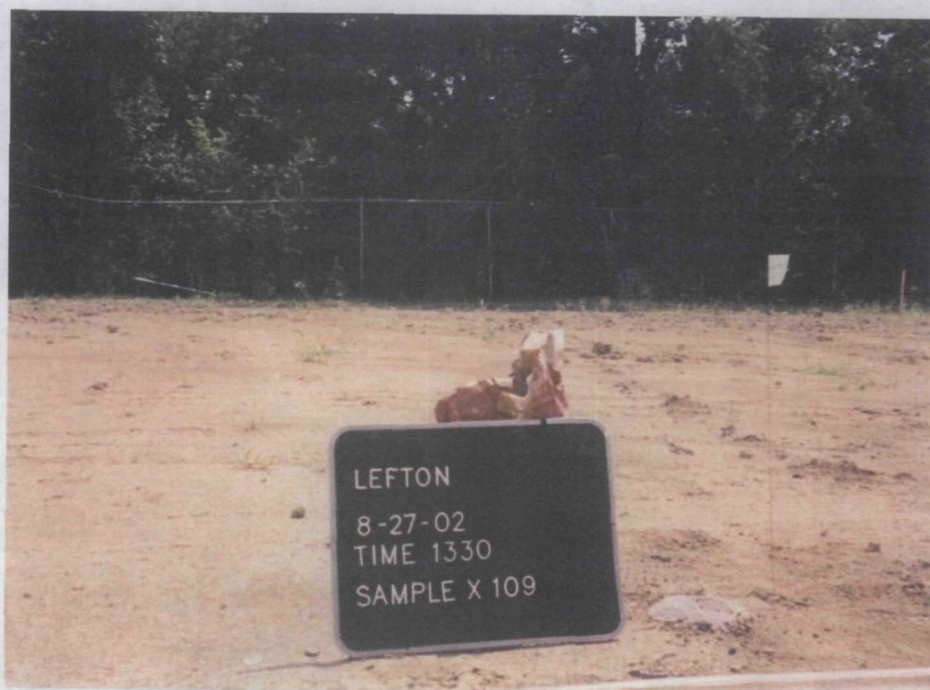
COMMENTS: Photo of soil samples X109 & X109A. The samples were collected in the main scrap yard area of the Converse Avenue facility.

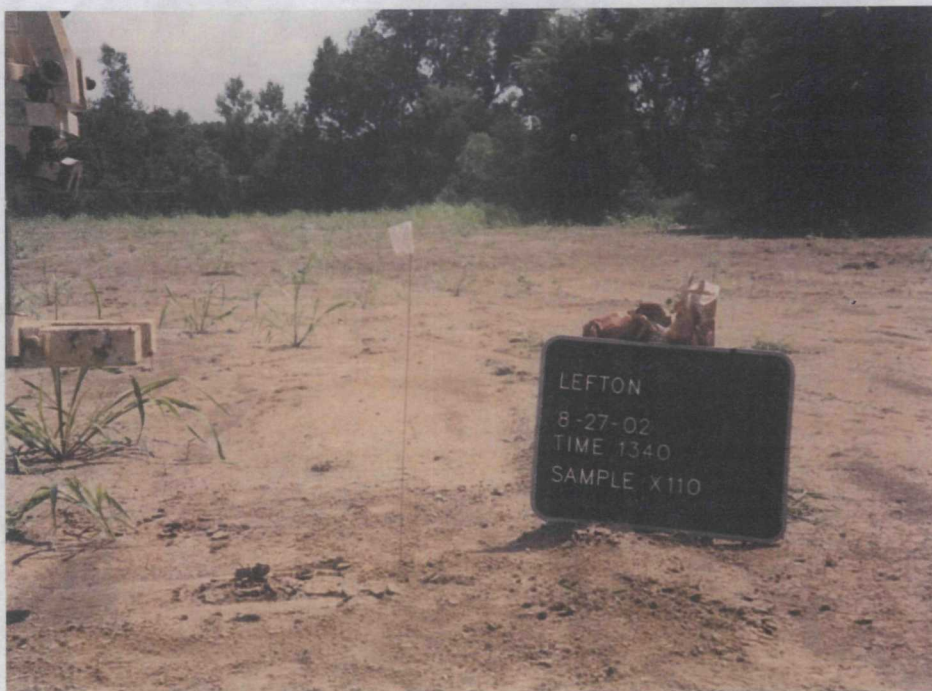
COMMENTS: Photograph of soil samples X110 & X110A. The samples were collected from the main scrap yard area of the Converse Avenue facility.

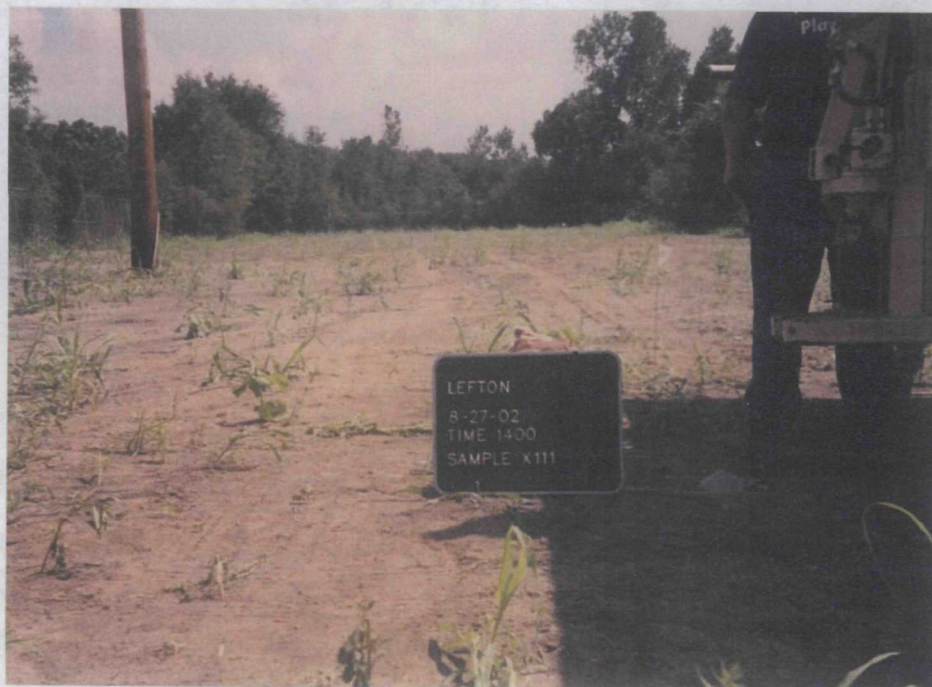
COMMENTS: Photograph of soil sample X111. X111 was collected along the northwestern edge of the Converse Avenue facility.

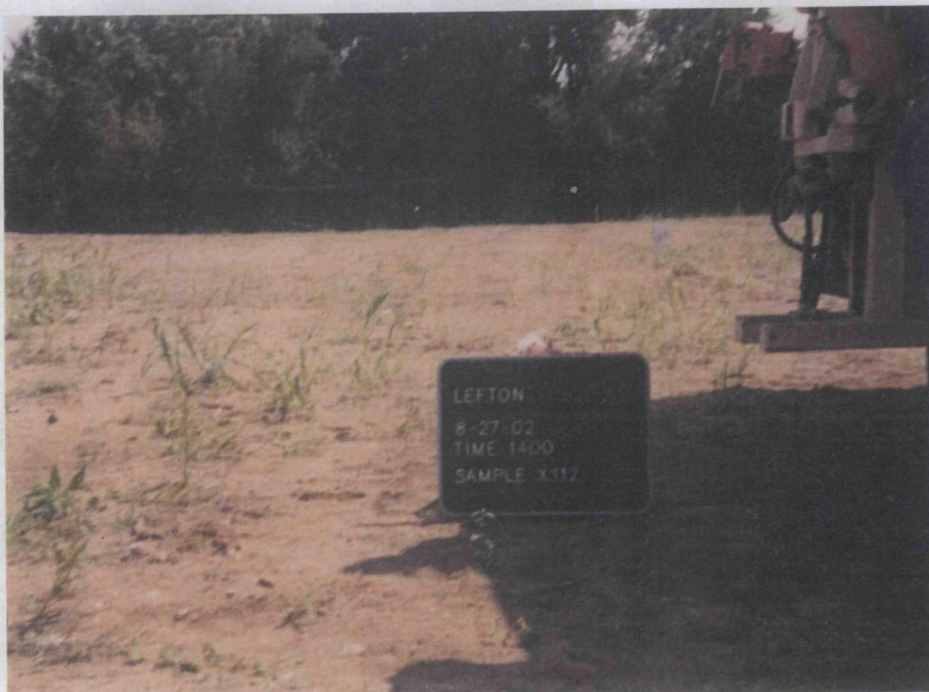
COMMENTS: Photo of soil sample X112. X112 was collected from the Converse Avenue facility. The time displayed on the photo board is incorrect.

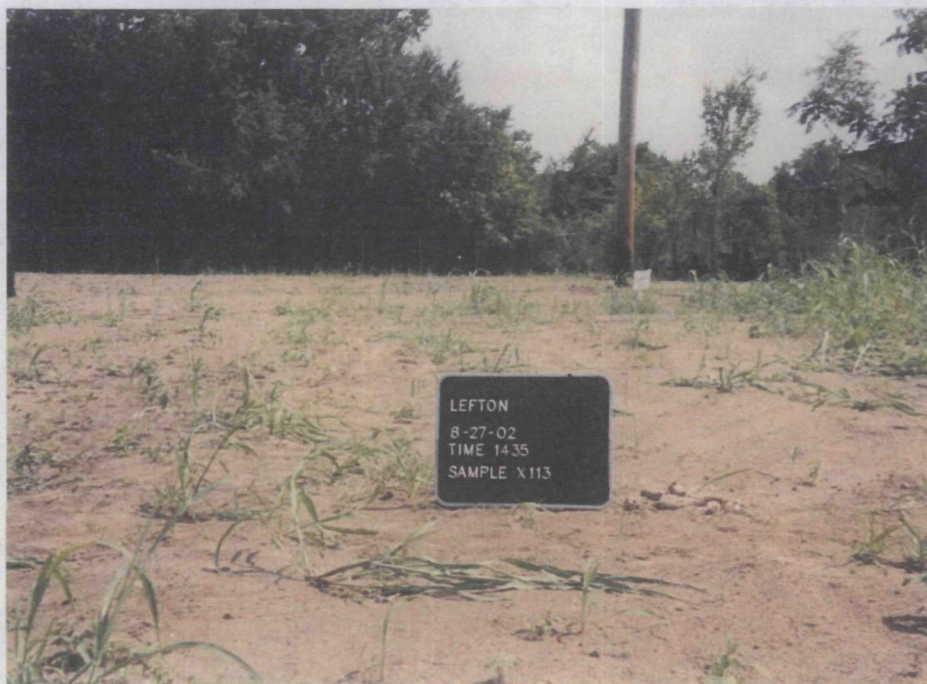
COMMENTS: Photograph of soil sample X113. X113 was collected from the main scrap yard area of the Converse Avenue facility.

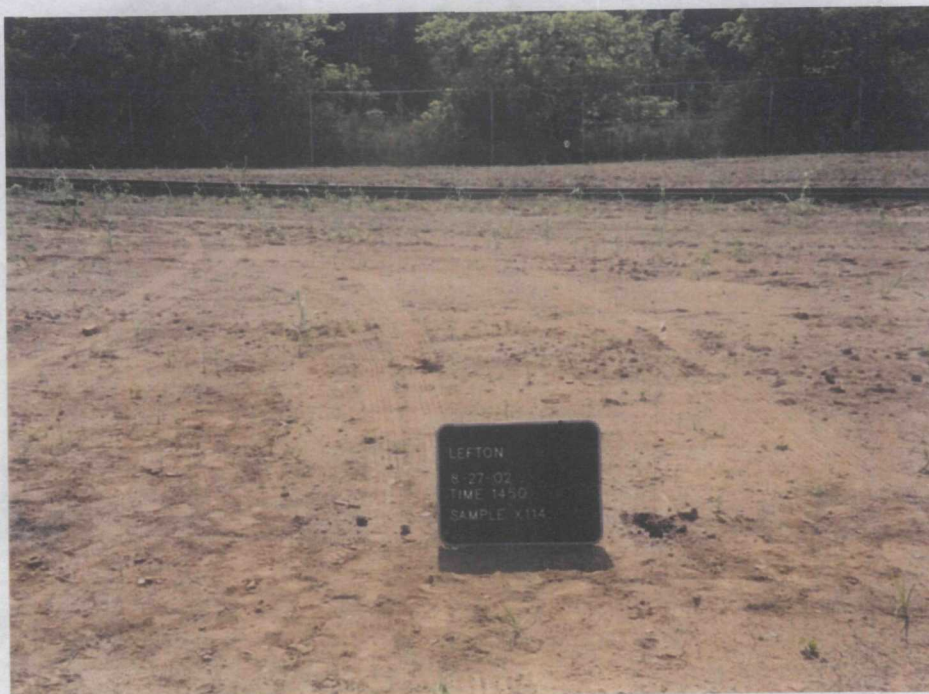
COMMENTS: Photograph of soil sample X114. X114 was from a central location of the Converse Avenue facility.

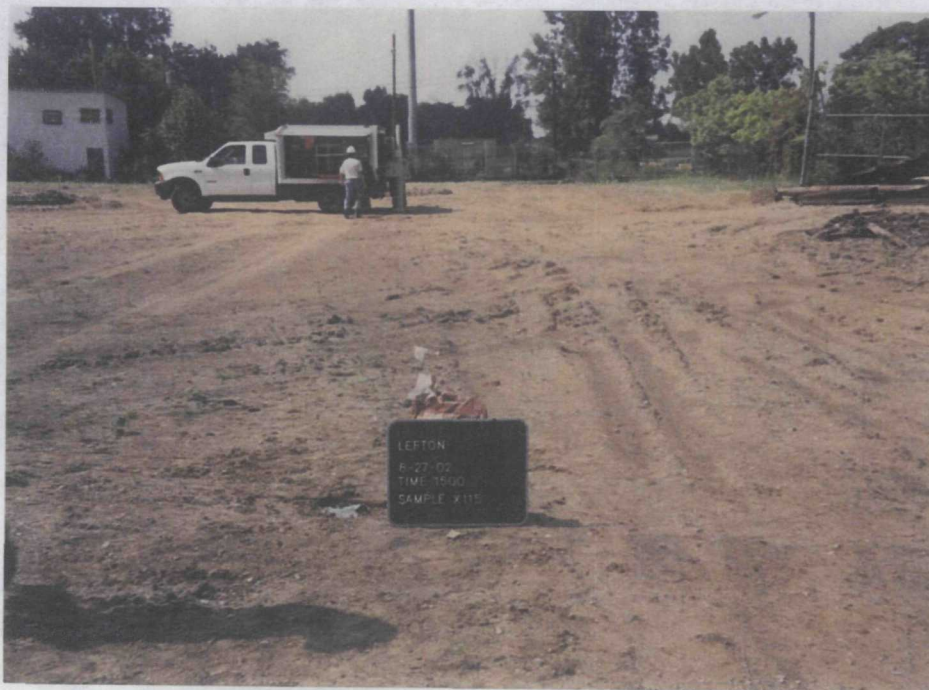
COMMENTS: Photograph of soil sample X115. X115 was collected along the northeastern boundary of the Converse Avenue facility.

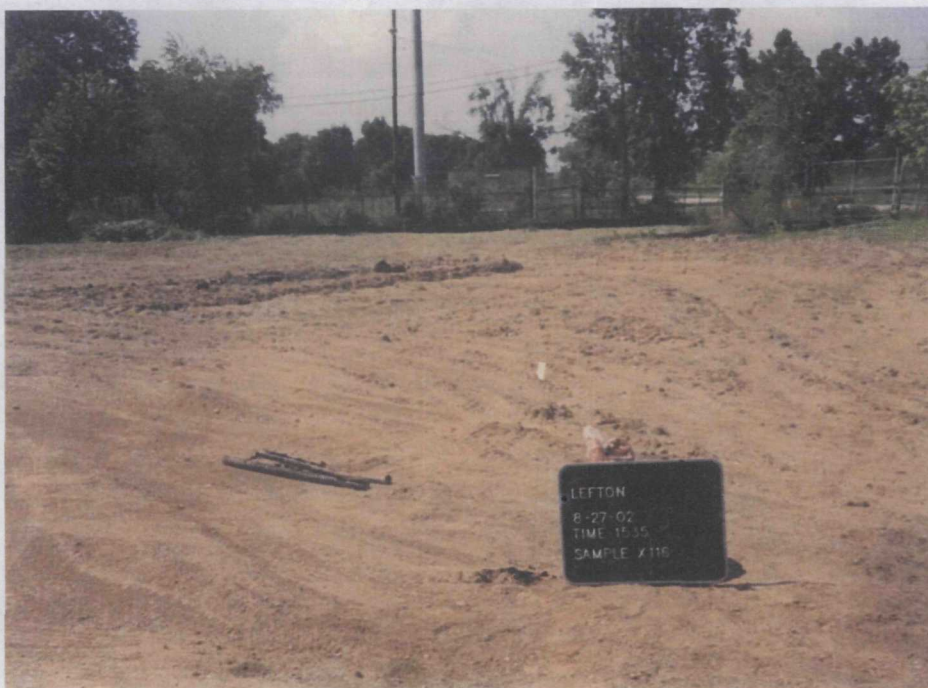
COMMENTS: Photograph of soil samples X116 & X116A. The samples were collected near the northeast corner of the Converse Avenue facility.

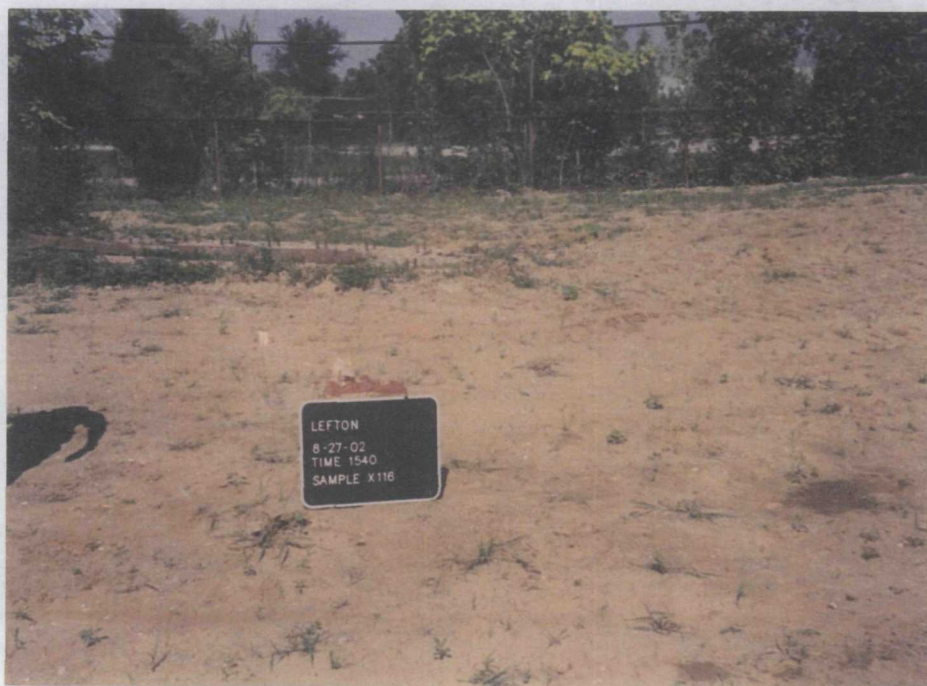
COMMENTS: Photograph of soil sample X117. X117 was collected from the northeast corner of the Converse Avenue scrap yard facility. The sample number is improperly indicated on the photo board as X116.

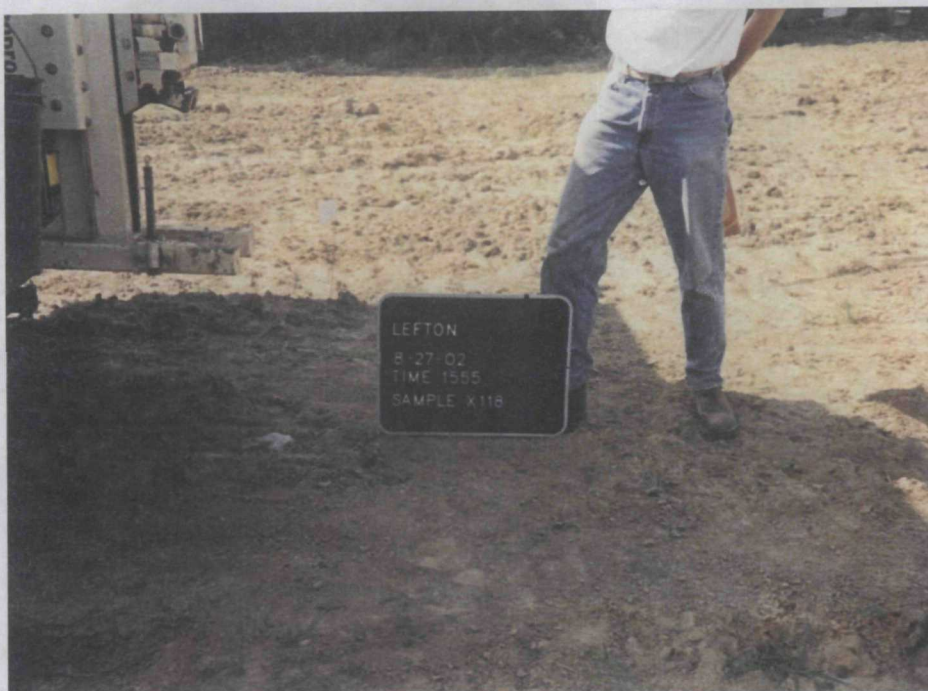
COMMENTS: Photograph of soil sample X118. X118 was collected in the north central portion of the Converse Avenue facility.

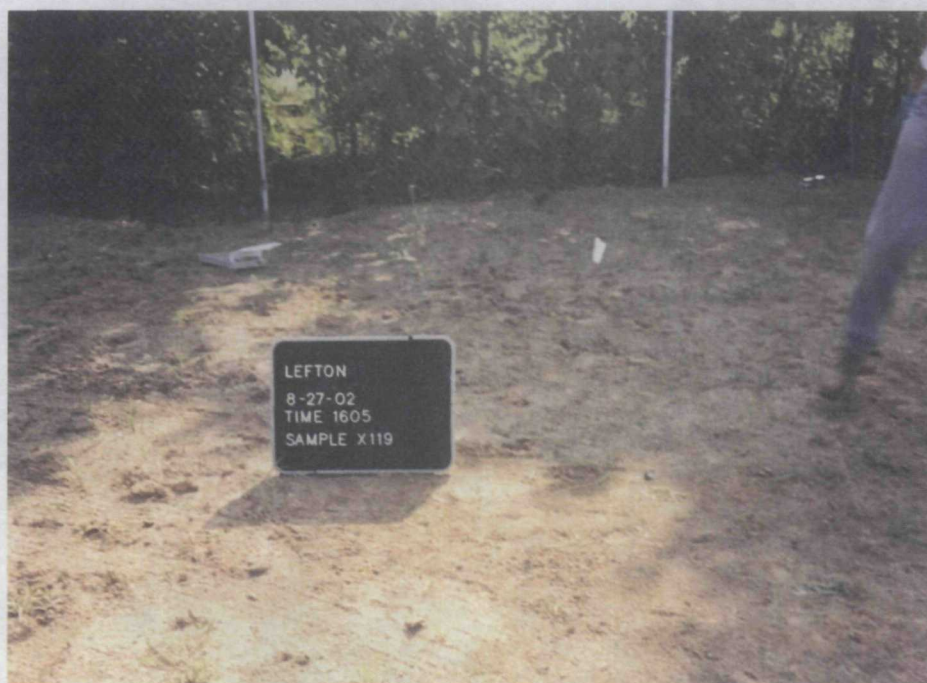
COMMENTS: Photograph of soil sample X119. X119 was collected in the northwestern corner of the Converse Avenue facility.

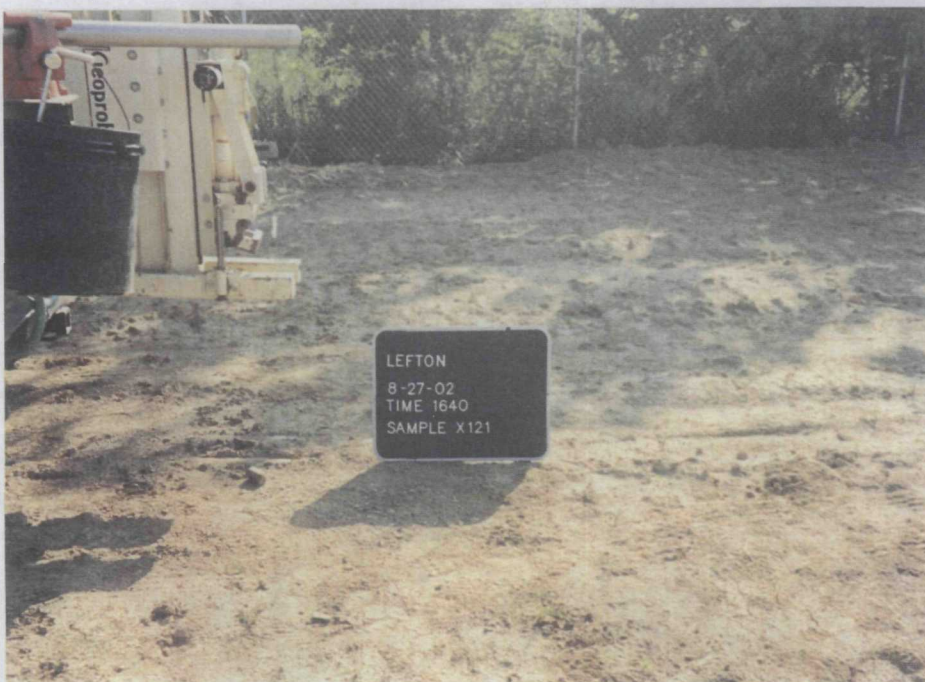
COMMENTS: Photograph of
soil sample X121. X121 was
collected from the central
portion of the Converse Avenue
in scrap yard area.

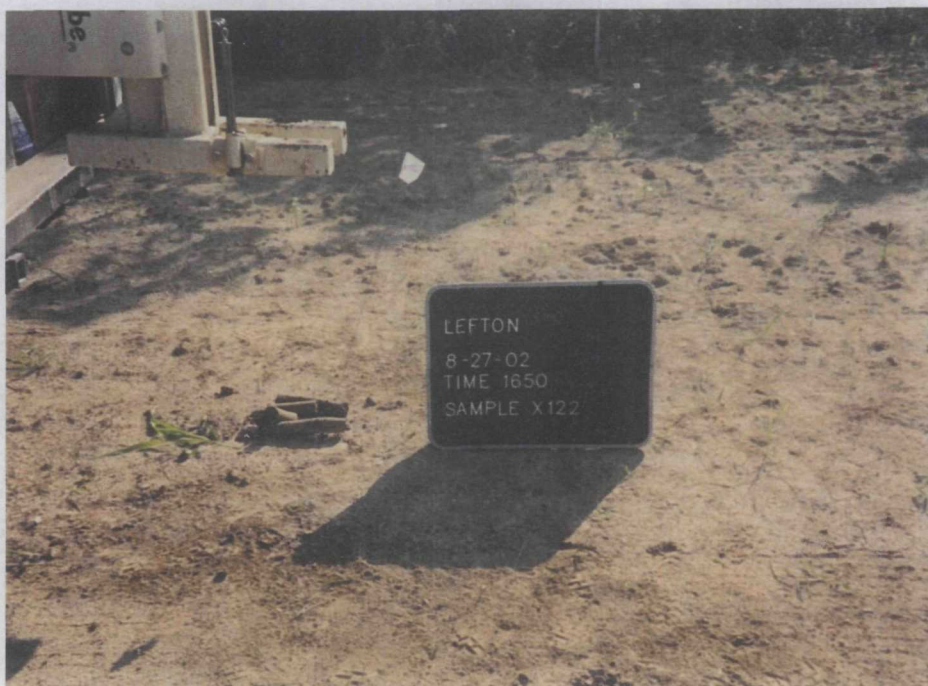
COMMENTS: Photograph of soil sample X122. X122 was collected from the central portion of the Converse Avenue main scrap yard area.

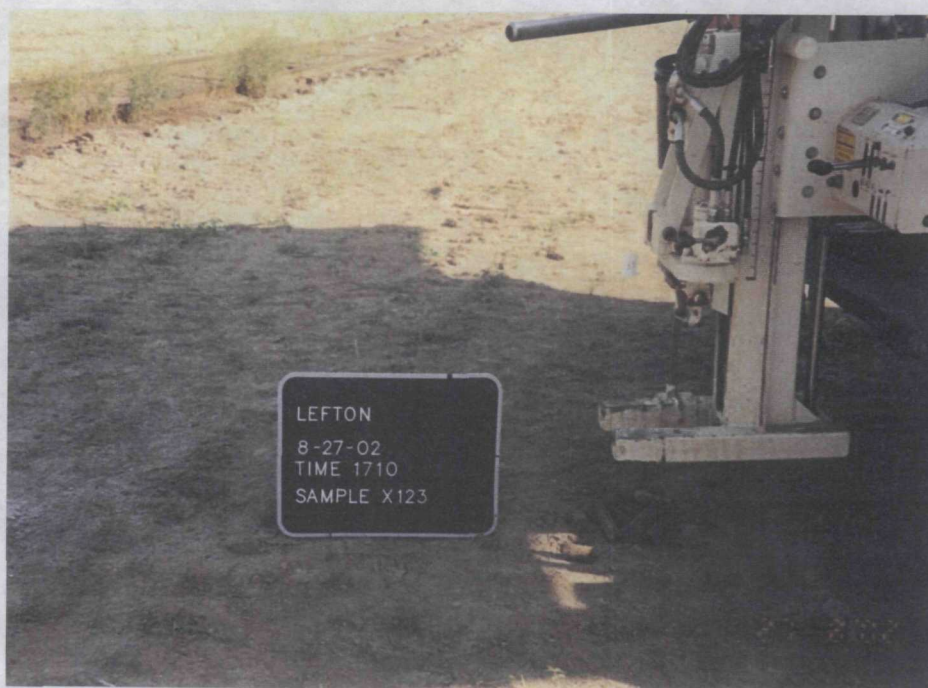
COMMENTS: Photograph of soil sample X123. X123 was collected from the main scrap yard area of the Converse Avenue facility.

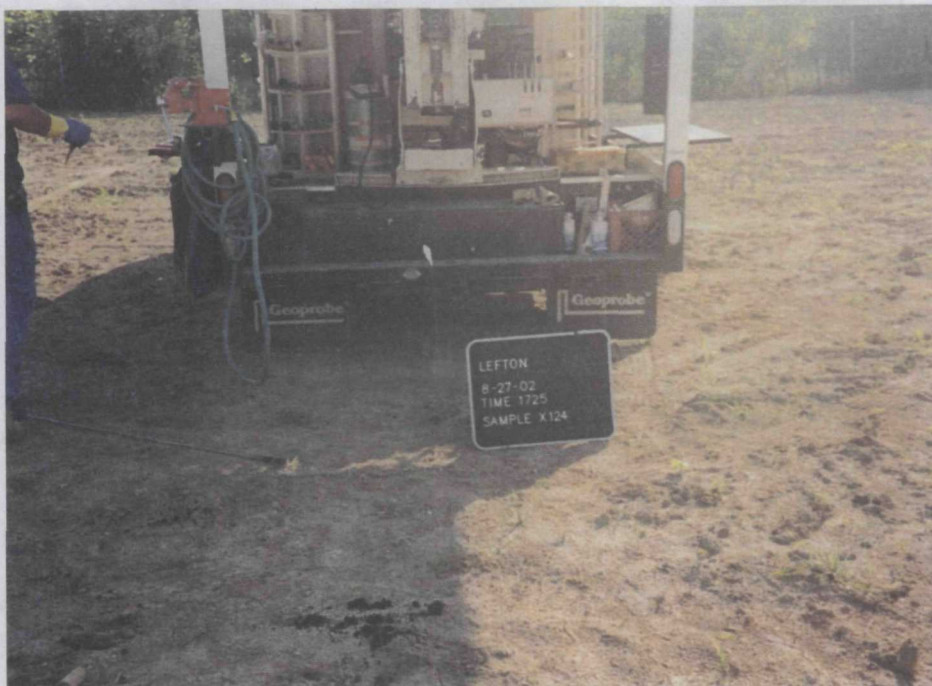
COMMENTS: Photograph of soil sample X124. X124 was collected from the main scrap yard area of the Converse Avenue facility.

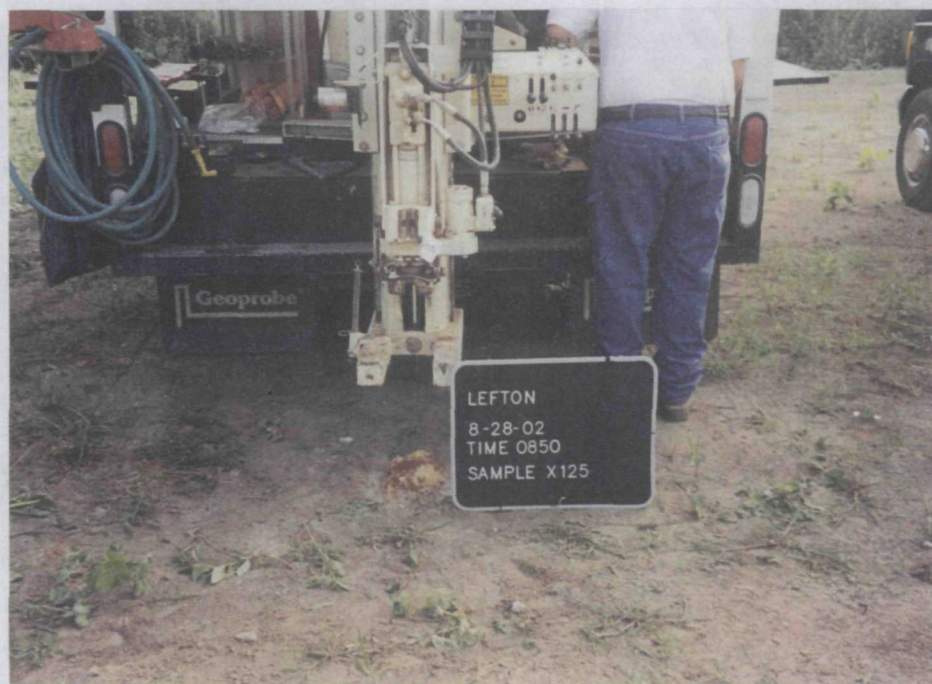
COMMENTS: Photograph of soil sample X125. X125 was collected from the northeast corner of the 17th Street facility.

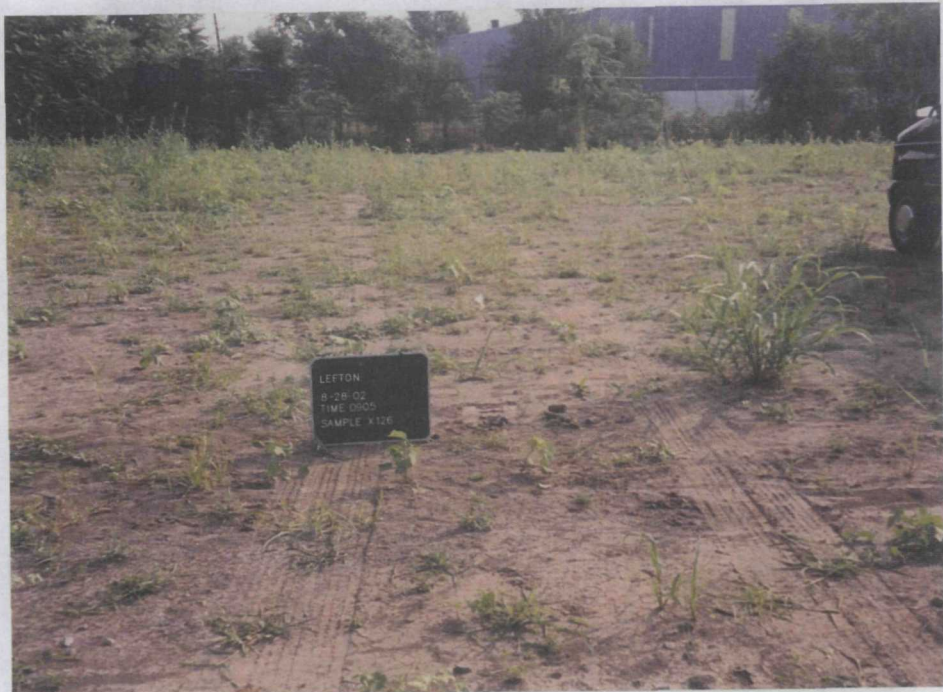
COMMENTS: Photo of soil samples X126 & X126A. The samples were collected near the northern property line of the 17th Street facility.

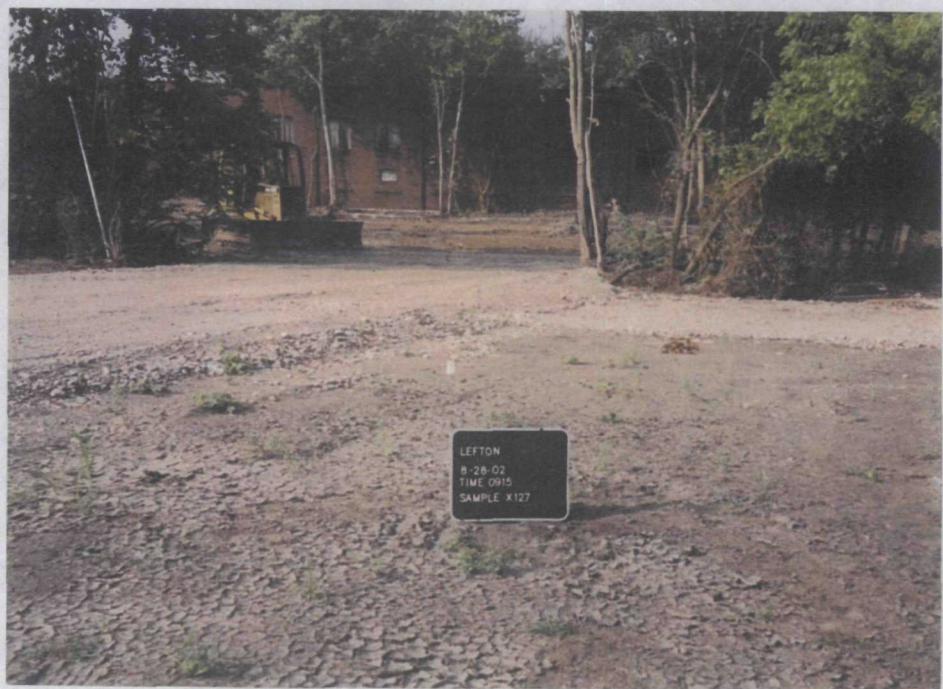
COMMENTS: Photograph of soil sample X127. X127 was collected in the north central area of the main scrap yard at the 17th Street facility.

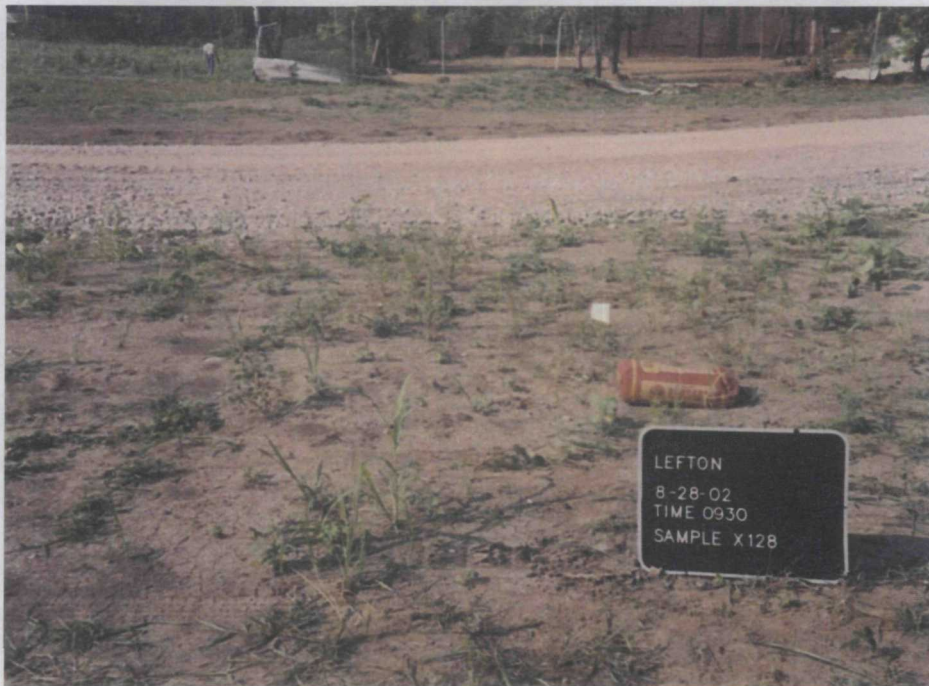
COMMENTS: Photograph of soil samples X128 & X128A. The samples were collected near northeastern corner of the 17th Street facility.

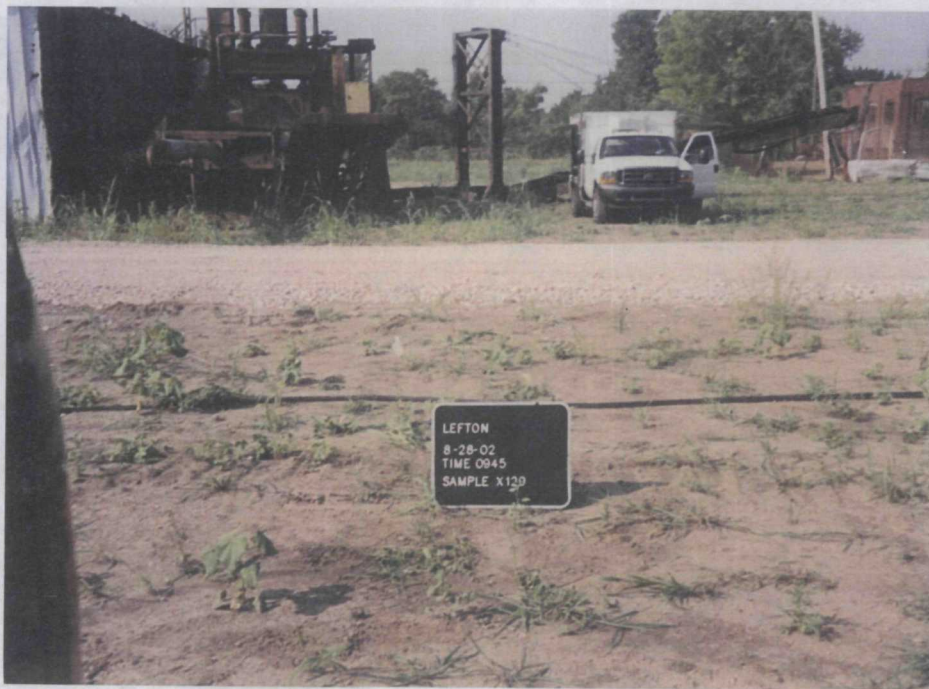
COMMENTS: Photograph of soil sample X129. X129 was collected from the central area of the main scrap yard at the 17th Street facility.

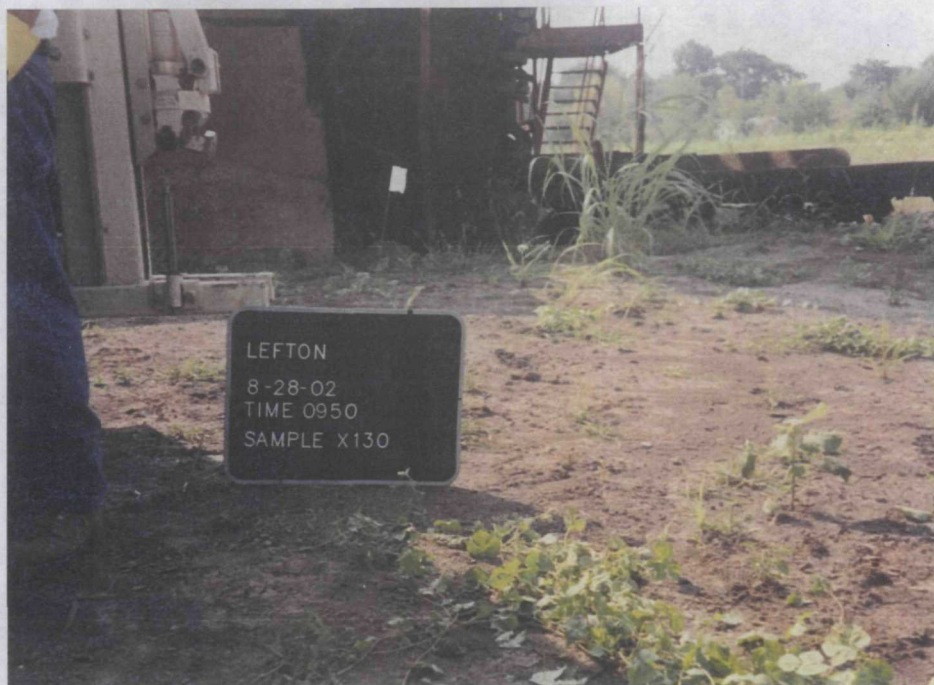
COMMENTS: Photograph of soil sample X130. X130 was collected from the main scrap yard area of the 17th Street facility. One of the on-site structures can be seen in the background.

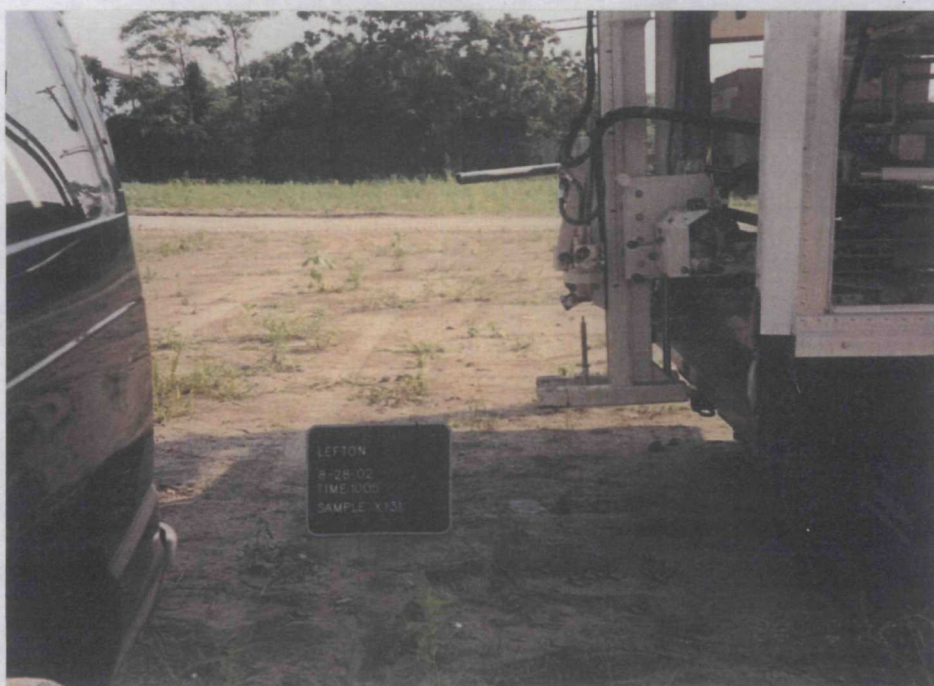
COMMENTS: Photograph of soil sample X131. X131 was collected from the main scrap yard area of the 17th Street facility.

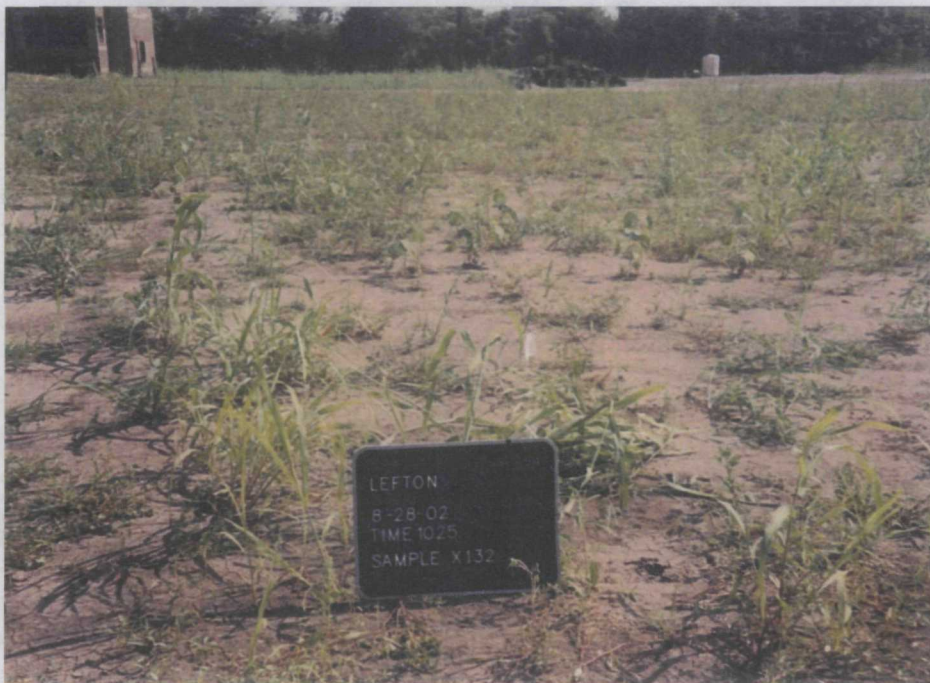
COMMENTS: Photograph of soil sample X132. X132 was collected from an area on the 17th Street facility where a former rail spur was located.

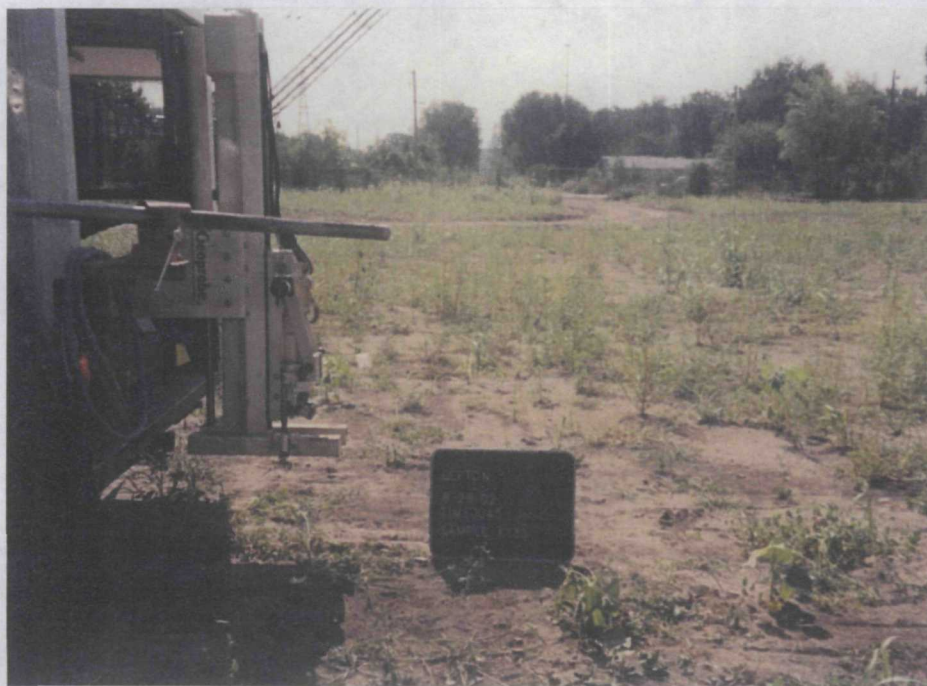
COMMENTS: Photograph of soil sample X133. X133 was collected from the main scrap yard area of the 17th Street facility.

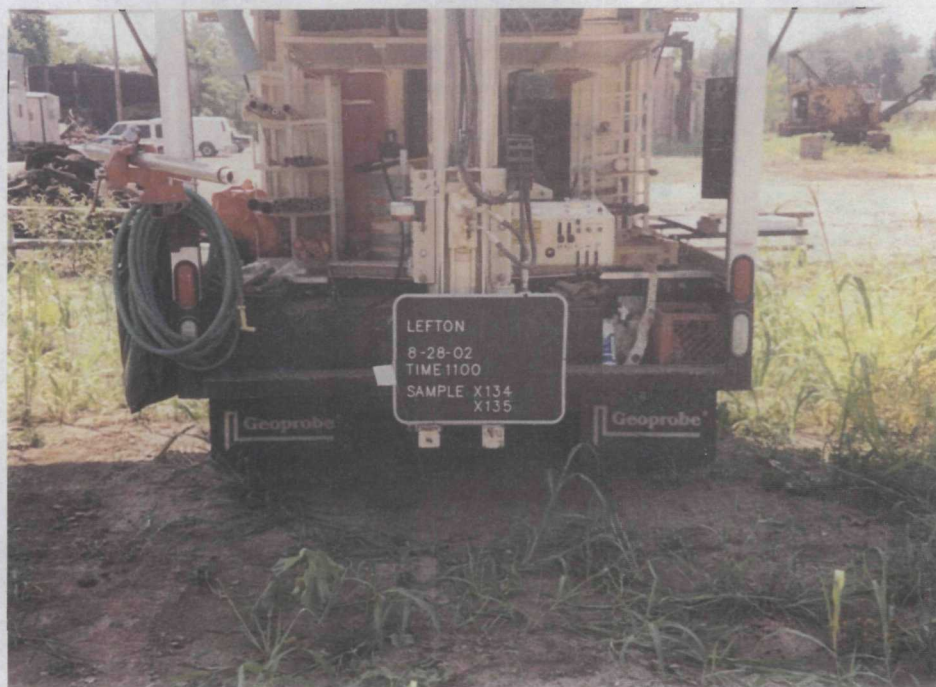
COMMENTS: Photograph of duplicate soil samples X134 & X135. The samples were collected from an area just north of the main offices at the 17th Street facility.

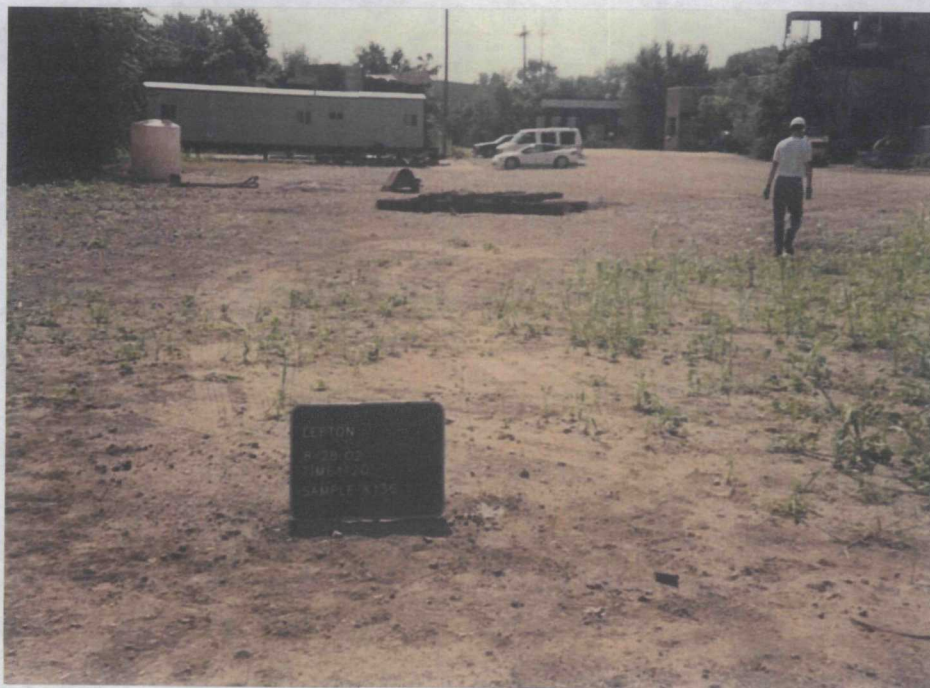
COMMENTS: Photograph of soil samples X136 & X136A. The samples were collected on the 17th Street facility. The samples were collected along northern property line.

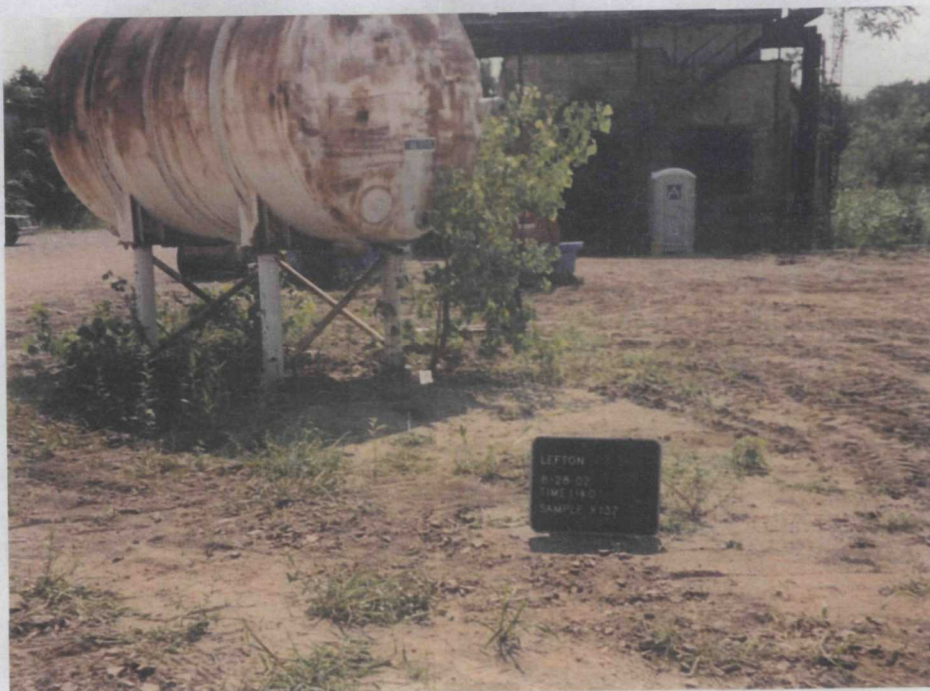
COMMENTS: Photograph of soil samples X137 & X137A. The samples were collected from the main scrap yard area of the 17th Street facility.
